WELDING INSPECTION REPORT

OSM Arrival Time: 700 **Project Name:** SAS Superstructure **OSM Departure Time:** 1900 **Prime Contractor:** American Bridge/Fluor Enterprises, a JV

34-0006 **Bridge No: Component:** Orthotropic Box Girder (OBG)

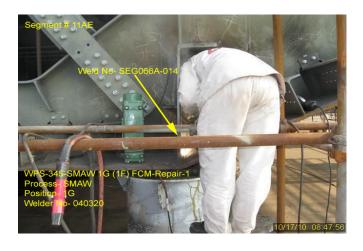
This QA inspector observed ZPMC qualified welding personnel identified as 040320 perform Shielded Metal Arc Welding (SMAW), weld joint identified as SEG059E-038; located On Orthotropic Box Girder (OBG) Bottom Plate to Side Plate CJP Weld; excavated weld due to UT rejected areas. The Critical Welding Repair Report (CWRR) was B-CWR2044. ZPMC Quality Control (QC) is identified as Mr. An Qing Xiang. The welding variables recorded by QC appeared to comply with the Applicable WPS-345-SMAW 1G (1F) FCM Repair-1 See the attached Photo.

This QA inspector observed ZPMC qualified welding personnel identified as 040656 perform Shielded Metal Arc Welding (SMAW), weld joint identified as OBW11B-003; located On Orthotropic Box Girder (OBG) Bottom Plate to Bottom Plate Transverse CJP Weld ;excavated weld due to Ultrasonic rejected areas. The Critical Welding Repair Report (CWRR) was B-CWR2052. ZPMC Quality Control (QC) is identified as Mr. Zhou Peng. The welding variables recorded by QC appeared to comply with the Applicable WPS-345-SMAW 4G (4F) FCM Repair-1. See the attached Photo.
